# Site Attendance Report

## Reported Fault(s)

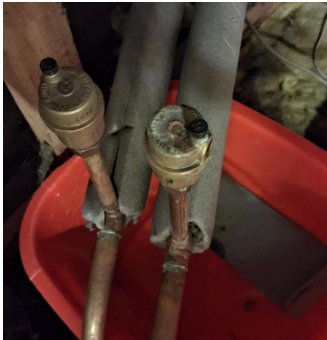
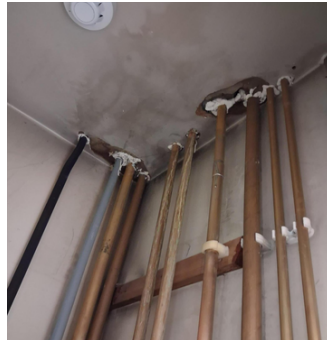
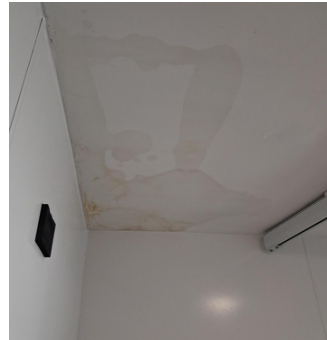
Noticed water coming under the bathroom radiator- we remove the radiator cover to check and noticed it was coming through the wall, the ceiling was also wet. I have check the loft where our water tank are located, and one of the pipe was leaking from the valve- we put the container underneath to store the water. I have noticed the water has gone around the loft area and there are lots of wires. Can this be look into as very urgent please.

Attended site to investigate a reported leak from the heating system. Upon inspection, the bottle air vent was found to be leaking due to general wear and tear, resulting in deterioration of the component. The faulty bottle air vent was removed and replaced with a new unit to restore the integrity of the system and prevent further water leakage. The replacement was completed successfully, with the affected area left safe and serviceable. Quote to follow to making the area look good.
